Case study:
Targeting improved performance
with 35% material cost reduction

International Smartphone OEM:

5V/1A PIC test, device connector

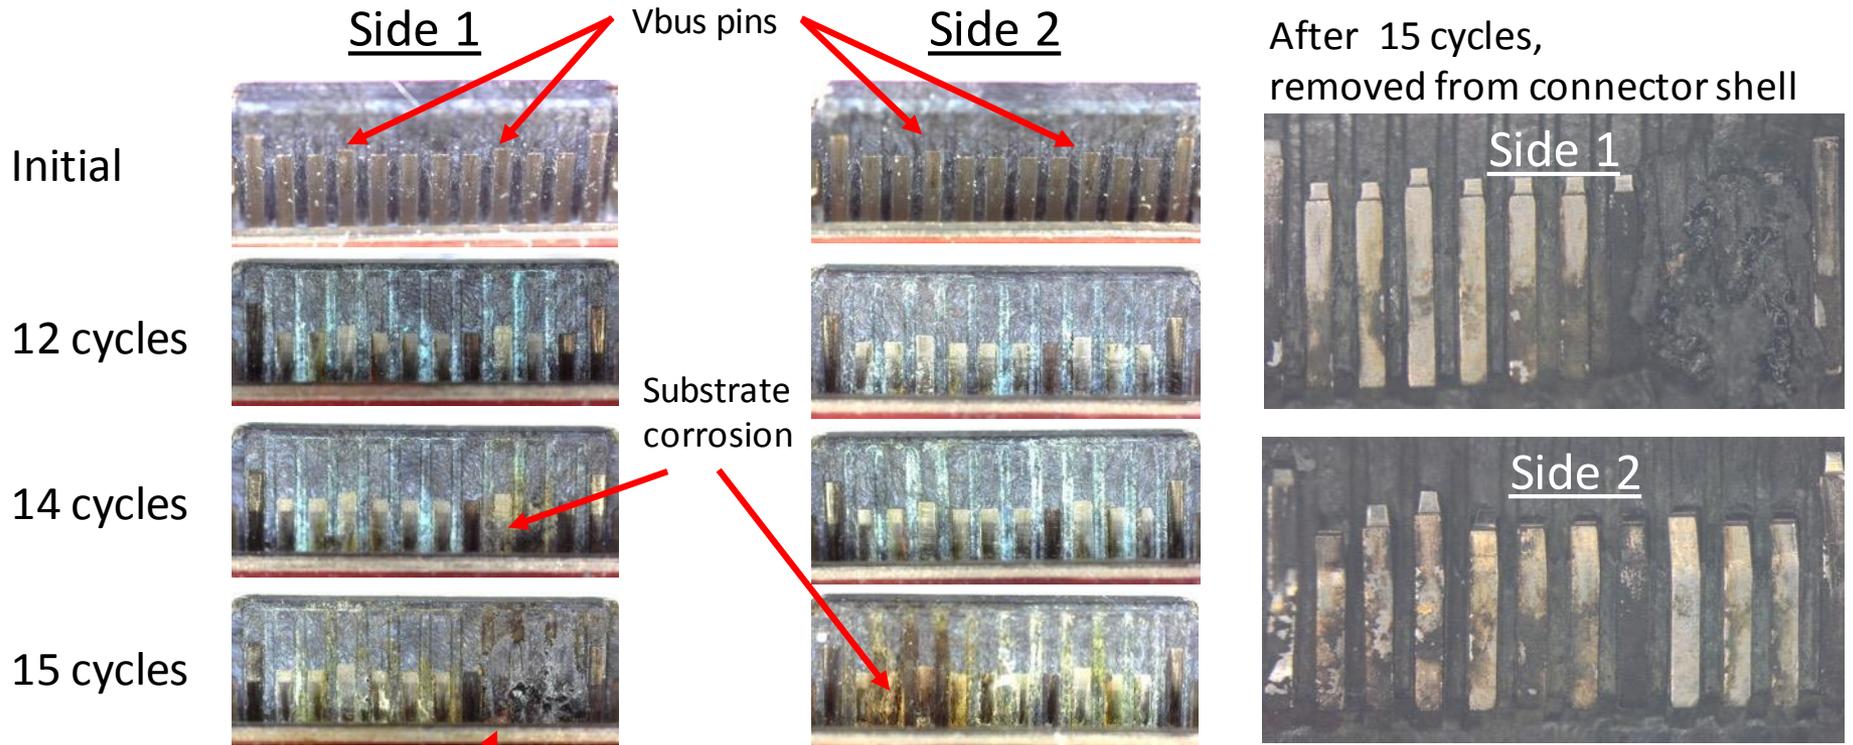
- Catastrophic failure at cycle 15
- Substrate corrosion obvious at cycle 14

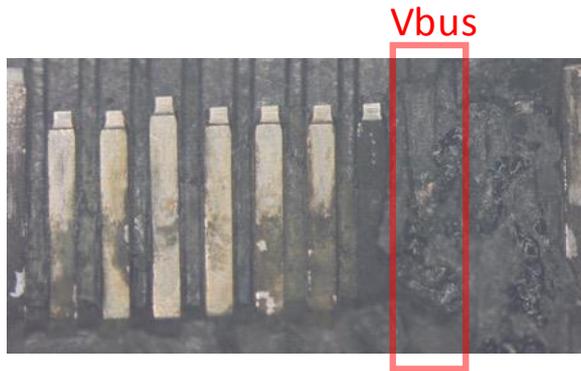
Corrosion product and melted plastic removed from Vbus contact

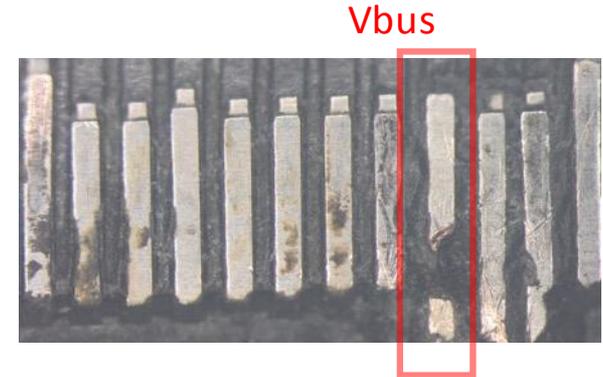
Thermal overload from corrosion caused connector plastic to melt around Vbus

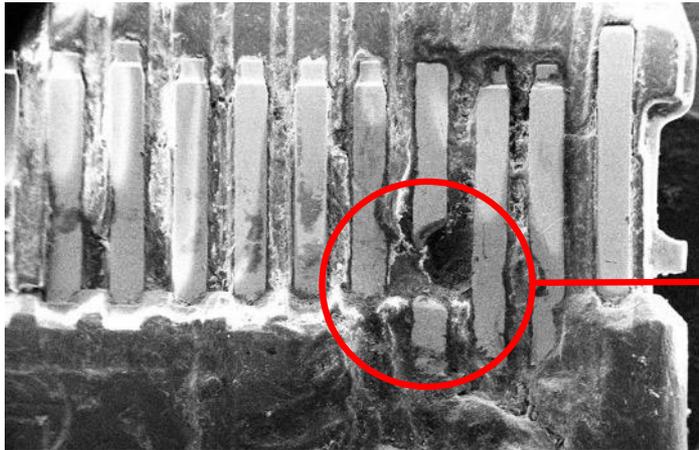
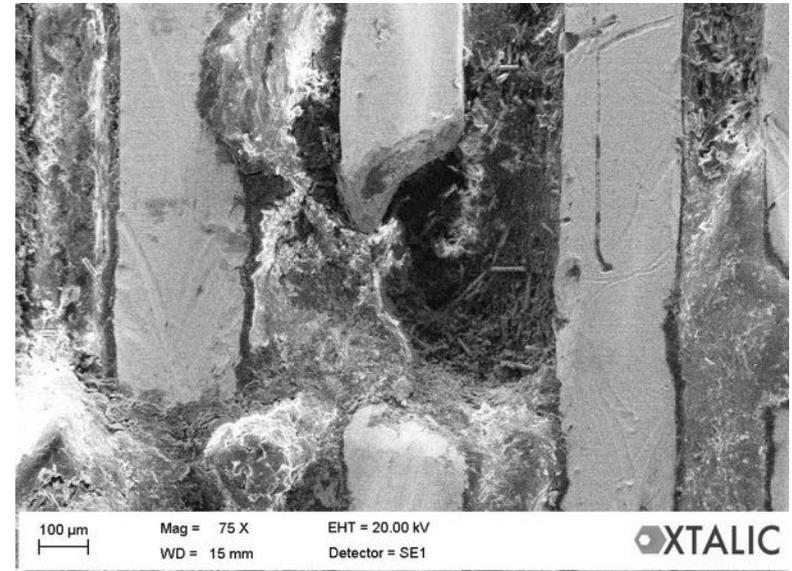
SEM images show Vbus contact completely corroded through

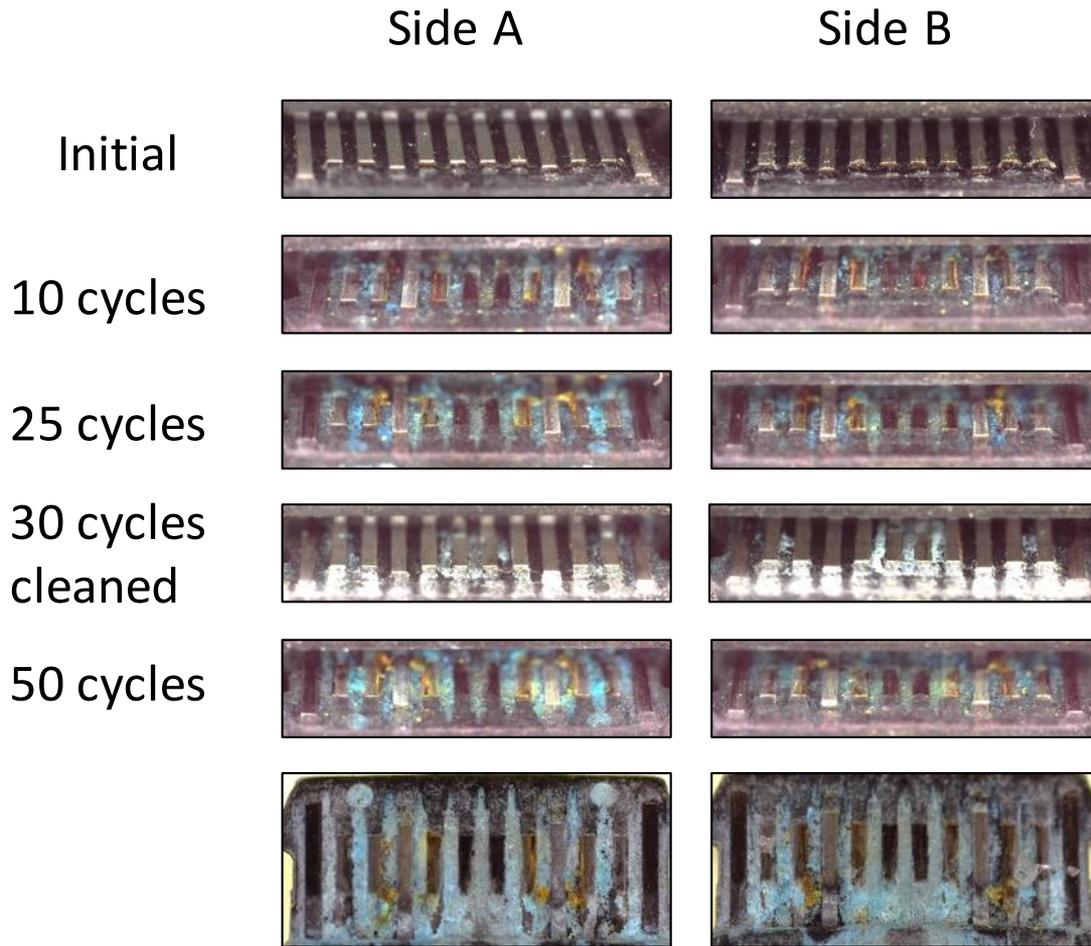
After 50 cycles,
removed from connector shell

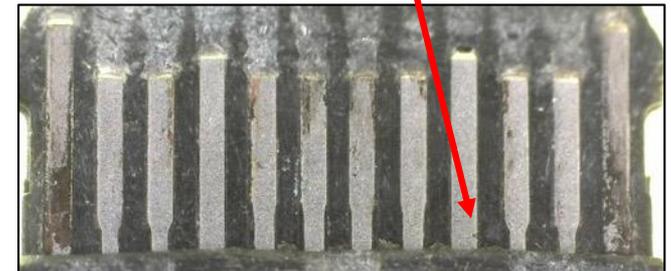
Side B

Exposed
substrate

- Test stopped at 50 cycles. Minor signs of substrate corrosion

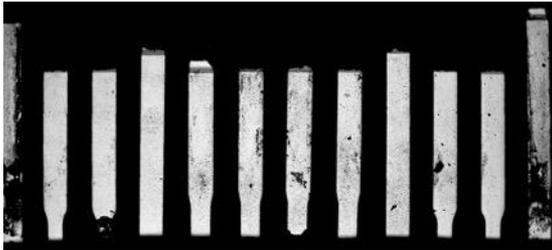
- No corrosion of Vbus pins on connector Side A

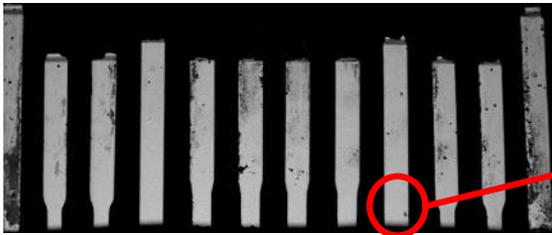
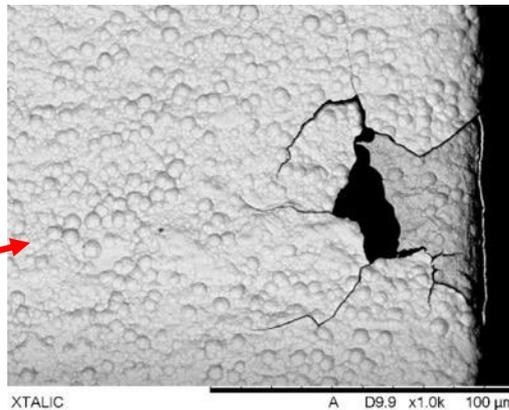
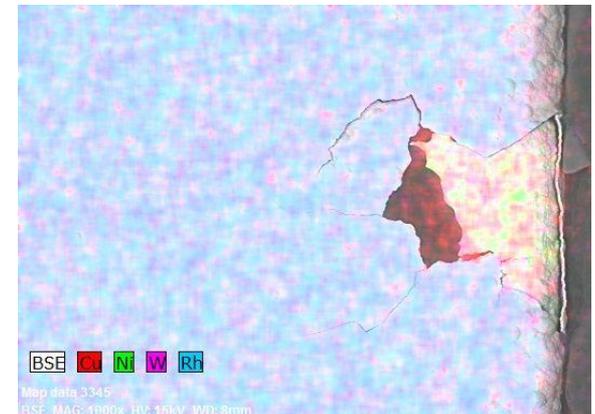
Side B

- Area of exposed substrate at base of Vbus pin on side B after 50 cycles, device still operational
