# Novel Nanocrystalline Silver Alloy Coatings to Boost Performance of EV High Voltage Interconnects and Charging Interfaces

Peteris Griffiths, Robert Hilty, Lisa Chan, and John Cahalen Xtallic Corporation

**Citation:** Griffiths, P., Hilty, R., Chan, L., and Cahalen, J., "Novel Nanocrystalline Silver Alloy Coatings to Boost Performance of EV High Voltage Interconnects and Charging Interfaces," SAE Technical Paper 2022-01-0723, 2022, doi:10.4271/2022-01-0723.

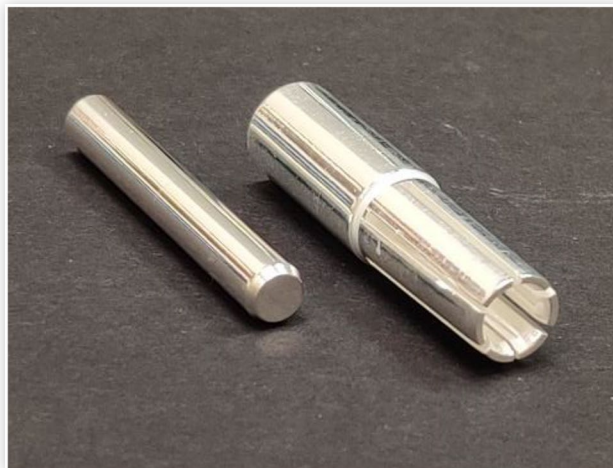
**FIGURE 1** Silver plated EV charging style connectors used for durability testing.

A connector test vehicle ([Figure 1](#). Silver plated EV charging style connectors used for durability testing) was designed to mimic the engineering features of typical electric vehicle charging connectors. The connectors were machined out of UNS C11000 copper substrate and were electroplated with both pure silver and NCSA for wear durability testing. The mating force of the connectors, as measured on a Chatillon DFS II, was between 6-8 N. The overall length of the connectors is 40 mm with six spring tines on the receptacle and the diameter of the mating plug pin is 6 mm. The contact gap of the receptacle as plated is 5.75 mm.

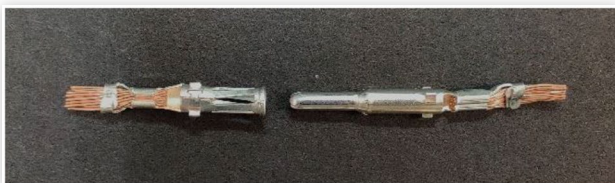
**FIGURE 3** Test connectors plated with NCSA.

To compare the operating capability of NCSA with silver, test connector pairs (Figure 3) consisting of a pin and receptacle were plated with  $5 \mu\text{m}$  of either NCSA or silver. The performance of the test connectors was conducted inside an oven at 95 C (Figure 4). Current was passed through the test connectors from 20A to 110A and the temperature rise of the test connectors was observed. Once the temperature had reached an equilibrium, the ambient temperature inside the oven and the temperature of the test connectors were recorded. Equilibrium is defined as when the temperature of the test connectors is constant for greater than five minutes.

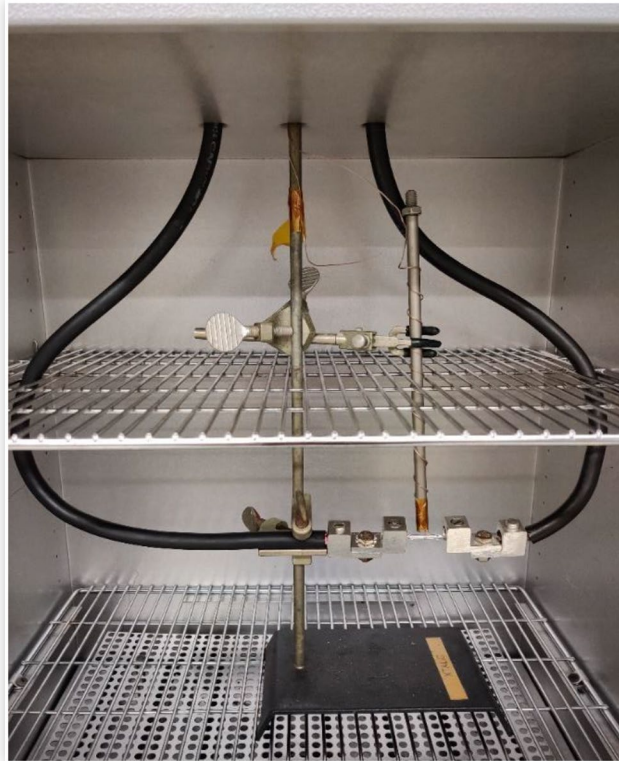
**FIGURE 4** Experimental current derating setup inside the oven.

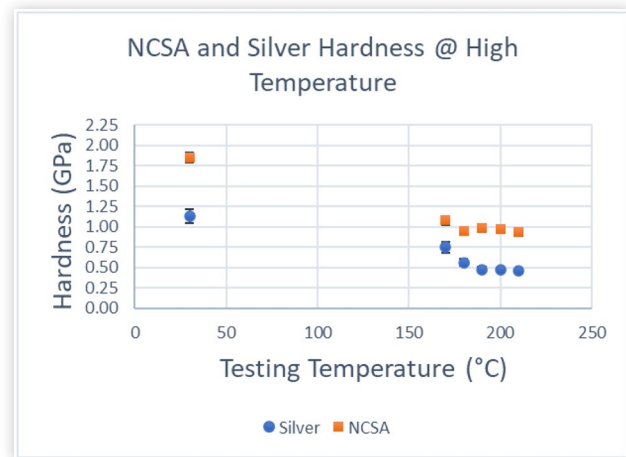
**FIGURE 13** Graphical representation of NCSA and silver hardness as a function of temperature, from Bruker Hysitron TI 980 Tribolindenter.

Across the range of temperatures tested, the NCSA sample was at minimum 45 % harder than the silver sample. The difference was further pronounced as temperatures rose higher; with the NCSA maintaining 2x hardness of silver at 190 °C and above.

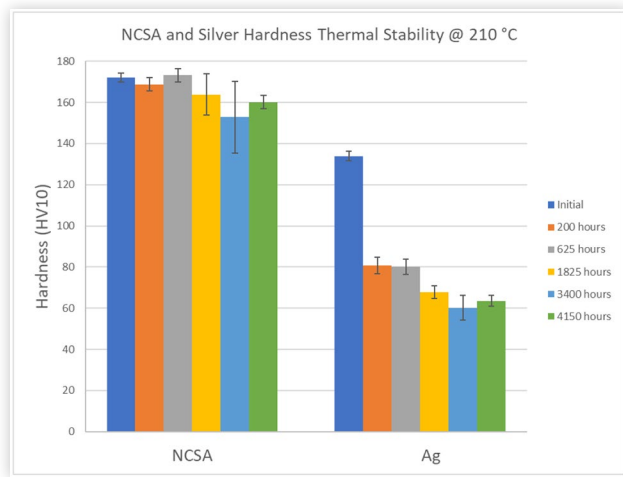
**FIGURE 14** NCSA and silver hardness after prolonged exposure to elevated temperature. The error bars indicate one standard deviation of the measured values

NCSA experiences a smaller drop in hardness relative to silver plating when exposed to elevated temperatures for a prolonged period of time. The NCSA samples used for this experiment

had an average starting hardness value of 172 HV<sub>10</sub>. The silver samples used for this testing had an average initial hardness value of 134 HV<sub>10</sub>. After 200 hours thermal exposure at 210 C the average hardness for the NCSA samples was 169 HV<sub>10</sub> while the average silver hardness was 81 HV<sub>10</sub>. The NCSA exhibited a drop in hardness of ~1 % while the silver samples dropped on average by 40 %. This trend continued throughout testing. After 4150 hours of exposure at 210 C, the NCSA samples on average had lost ~ 7 % of their initial hardness compared to the silver samples which had lost ~ 53 % of their initial hardness values.

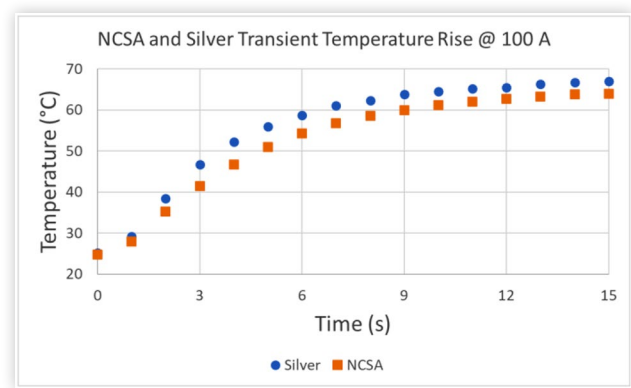
**FIGURE 15** Graphical representation of the initial temperature rise with applied current of NCSA and silver at ambient temperature.

**Current Derating** Upon initial application of current, the temperature rise is rapid and nearly equilibrates after 10 seconds. Figure 15 shows the temperature rise of silver and NCSA plated connectors when 100 A is applied. At a starting ambient temperature of 25 C, NCSA experienced a 3 C lower temperature rise than silver after the first 15 seconds.

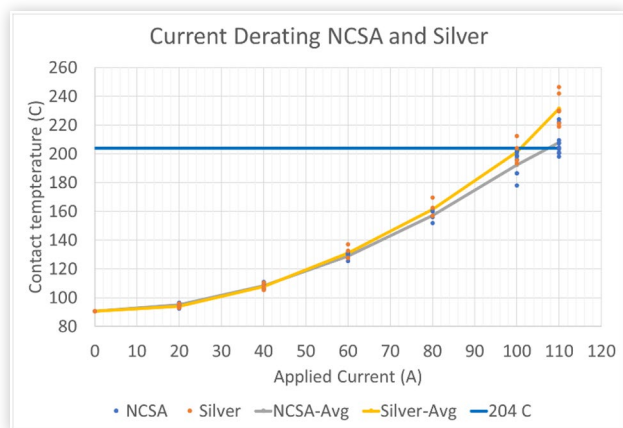
**FIGURE 16** Graphical representation of the temperature rise with applied current for various connector coatings.

Table 4 and Figure 16 show the performance of NCSA and silver coated connectors with applied current. Individual datum for each test run are shown on the graph along with an average result for each coating. As currents increased above 60 A, NCSA began to show lower temperature in the connector for the same current. At 110 A, NCSA demonstrates a 10% lower temperature rise than silver.
